## **OPERATOR'S MANUAL**

***HIGH PERFORMANCE CONCAVE UPGRADE KIT  
For Case IH\* Mid-Range and Legacy Series Combines***

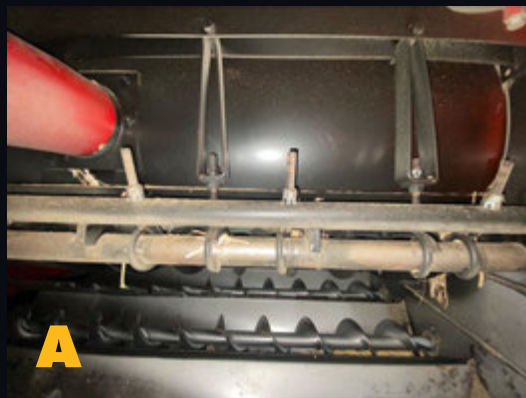
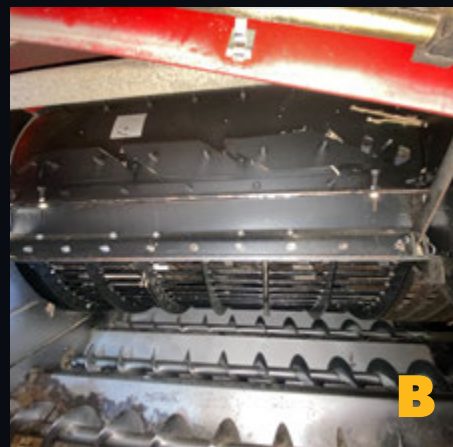
1. **From the cab, set concave clearance to 0.**
2. **Loosen eye bolts on double pipe clamp on RH side of concave. (image A)**
3. **Remove the mounting bolts on the LH side of concave #2 and #3 and remove both concaves.(image B)**

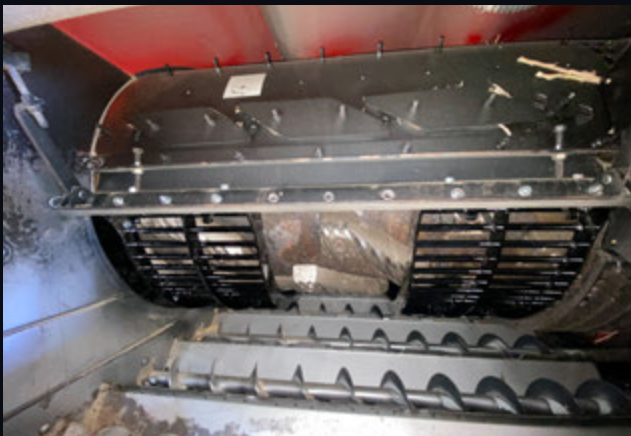
4. **Remove all cover plates and MOG limiting inserts from all 3 Calmer concaves.**
5. **Install Calmer Enhanced Flow Concave in position #3.**
  - a. **Install mounting bolts on LH side.**
6. **Remove mounting bolts on concave #1 and remove this concave.**
7. **Install Calmer Enhanced Flow concave with transition cone into position #1.**
  - a. **Install mounting bolts on LH side.**
8. **Level the concaves by following the step-by-step instructions found in your combine owner's manual.**

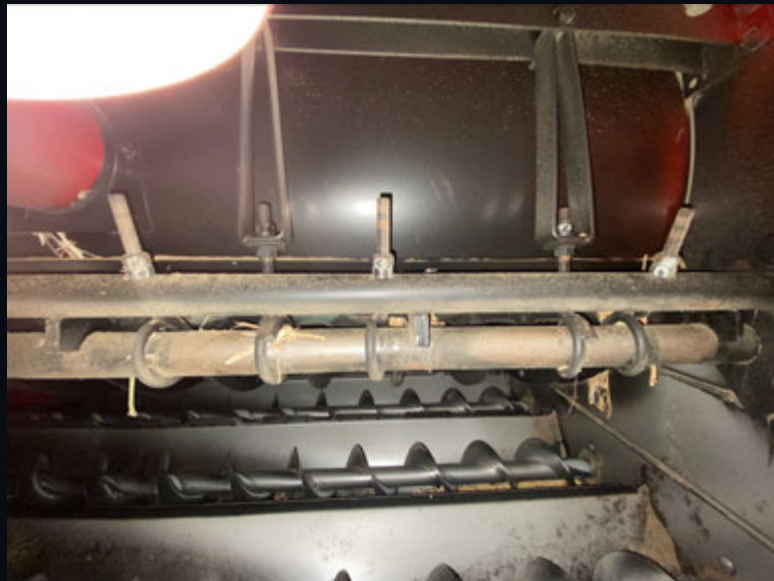
9. **Install Calmer Enhanced Flow concave in position #2.**
  - a. **If #2 concave doesn't fit between #1 & #3 concaves you may need to loosen the mounting bolts to slide concaves to accommodate each other.**
  - b. **Install mounting bolts on LH side.**
  - c. **Tighten eye bolts on double pipe clamp on RH side of concaves.**
  - d. **Retighten all mounting bolts on RH side of concave.**
10. **Calmer Enhanced Flow concaves have now been successfully installed.**
